Manhole Inspection Summary

Manhole # **S37EE_048MH**

Insp Date: **7/28/08 3:09 PM**

Location Address: **1107 FORREST ST**

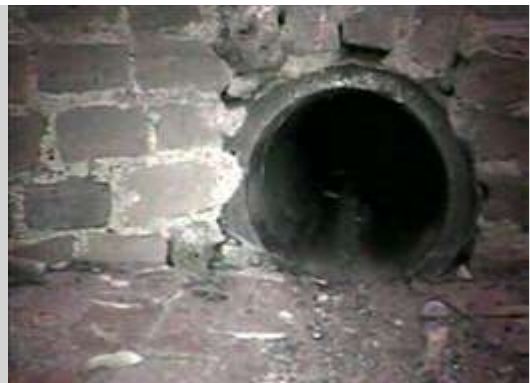
12 O'Clock Outflow

8 in. Circular Gravity Sewer
Pipe Out @ 12 O'Clock

Pipe Material: **Clay** ☐ Pipe Lined

Invert Depth: **7.69** (ft.) Flow Characteristics: **None**

Deposits: ☒ None ☐ Mud ☐ Sludge ☐ Debris ☐ Grease

Infiltration: **None** Pipe Seal Cond: **Sound**
